PAGAN newsletter 1985

Strengthening Pagan monuments

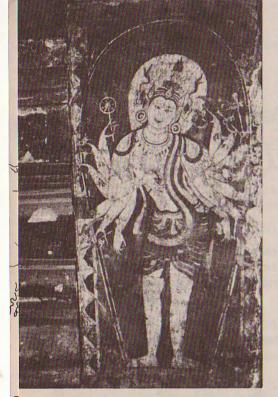
The Kyaukku Umin temple 154 is a very special case amongst pagan monuments, from several points of view. Located at the north-east border of the archaeological area, near Irrawaddy River, the temple was built along the steep edge of a ravine; its ground floor, level with the bottom of the ravine, opens to the north and is centered on a vaulted shrine surrounded by a corridor. Two large pillars support the vaults, while the back wall is built against the cliff, under which tunnels have been dug. The upper storey, built later on the terrace, comes to the level of the alluvial plateau. Another rare feature is the sandstone facing of its walls, outside as well as inside, the usual brick masonry being thus restricted to the inner part of the walls and to the upper storey. Very fine 12th century stone carving adorns the ground floor, outside and inside.

After the 1975 earthquake, several vertical cracks were observed in the walls. Further analysis revealed that these cracks originated from before the shock, which merely widened them, and the structural analysis showed that the original building was strong enough to withstand severe earthquakes. The restoration of its initial structural integrity, which is thus sufficient to meet the specified seismic criteria, has been achieved with two L shaped reinforced concrete belts, inserted in the upper parts of the walls, behind the cornice of each storey. In addition, local reinforcements and injections will be carried out along the former cracks.

Completing the reinforced concrete belt on Kyaukku Umin 154.

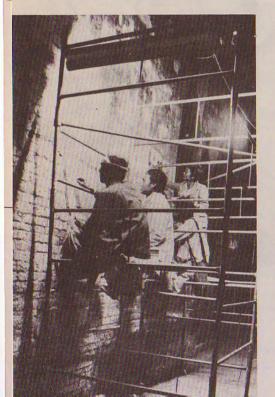
After treatment, painting of Skanda Kārttikeya guarding the entrance to the central shrine.

After removal of a polyvinyl acetate layer applied during a previous restoration, using a mixture of butylamine, acetate and water in equal parts, with 24 hours pauses to avoid damaging the original pigment layer, the dirt, composed of dust, soot, insect or bat dropping, and possibly an old fixative, was carefully removed by an equal-part mixture of hydranal (a disodium salt of ethylene-diamine-tetraacetic acid) and a 10% aqueous solution of ammonium carbonate, applied through cellulose-pulp compresses or through a sheet of local tissue-paper for about 6-8 minutes.

Additional fine cleaning was performed after pauses of 24 hours to allow the pigment layer to regain its strength. Consolidation of the support was made by injections of local sifted earth mixed with primal AC33 (acrylic resin water emulsion) in all hollow places, detached areas and insects tunnels.

The cleaned painting was provided a final protection by a reversible solution of paraloid B 72 in toluene (3%).

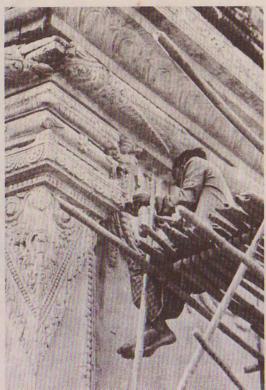
Clearing the stucco mouldings, north-east corner.

The external stuccoes were cleaned of dust, mosses and lichens by sponges and brushes after dampening of the surface. They were also consolidated and fixed by a mixture of:

- one part hydraulic lime (chaux blanche Lafarge)
- one part brick powder (sifted on 150 mesh)
- primal, 5% of the volume of the dry lime
- sodium gluconate 10% water solution, 1% of the volume of the dry lime
- water as required.
